PROFESSIONAL RESERVE STUDY

Nisqually Pines Community Club

August 1, 2022

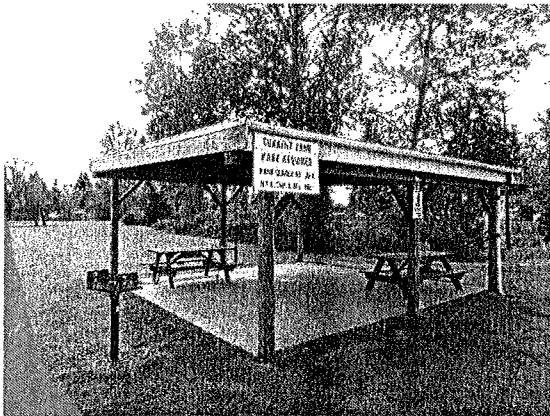
Picnic Shelter

We have budgeted for a picnic shelters and picnic assets allotment to be used to add or replace picnic tables and benches and to make repairs to the picnic shelters.

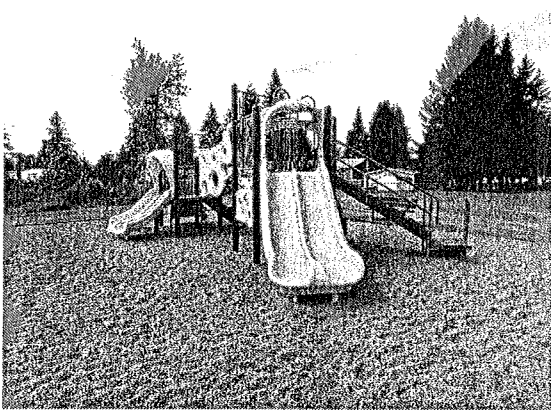
There is a playground in the central private park of this development, with a play set with several slides as well as a large swing set. Additionally, there is a swing set in the park at the intersection of Thuja Avenue and Pepperidge Lane. We have budgeted for a playground equipment allotment every 20 years. The playground equipment is currently in good condition.

Playground Equipment

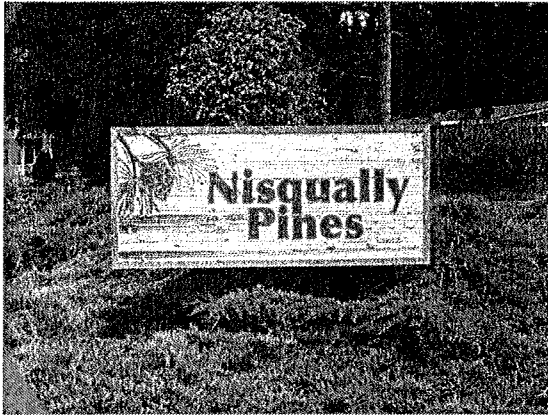
There are two property signs. These signs will need to be repainted within the near future. We have budgeted for painting of these signs every 5 years, and replacement every 20 years.

One of Two Signs

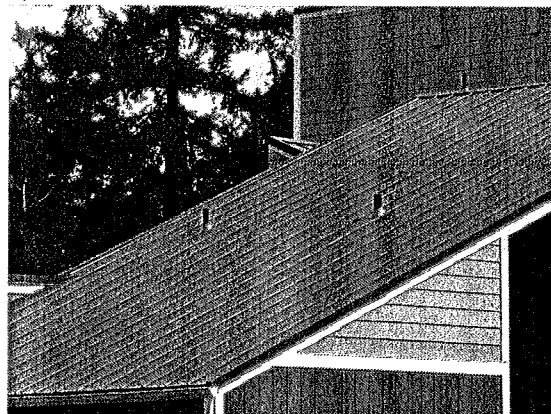
The roof of the clubhouse is pitched and is surfaced with standing seam metal roof surfacing. This roof was resurfaced in 2018 and should have a total lifespan of 50 years or more.

Metal Roof on Clubhouse

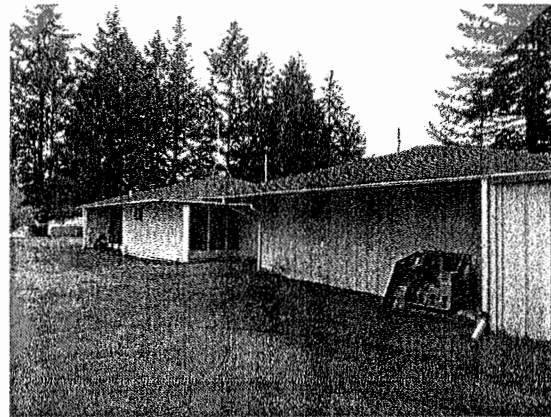
The office is sided with wood siding and is in need of paint; however, the exterior of the office is painted as part of the main budget outside of the Reserve Fund. Spot siding and trim replacement will likely be necessary at each painting cycle.

Front of Office/Garage

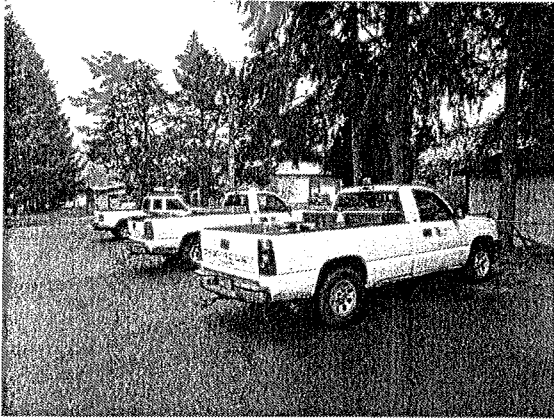
3 Maintenance Trucks

There are 3 maintenance trucks that are owned by the Association. One of these trucks is new. We have budgeted for one used truck to be purchased every 5 years.

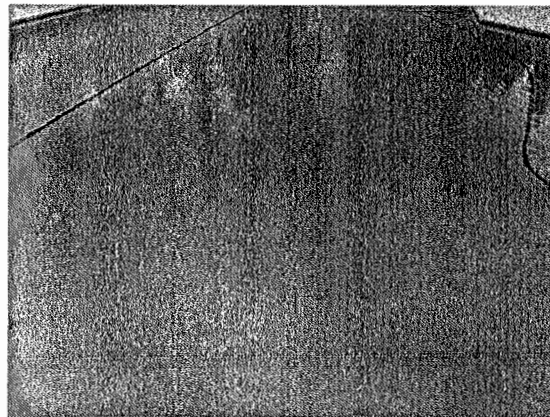
Close-up of Swimming Pool Plaster

3.13 AMENITIES								
Swimming pool leak repairs	1	LS	\$20,000	0	N/A	\$20,000	\$24.18	N/A
Re-plaster swimming pool	3,378	SF	\$16.50	0	25	\$55,737	\$67.40	\$2.70
Re-tile swimming pool	1	LS	\$5,760	0	25	\$5,760	\$6.96	\$0.28
Replace pool pump	1	EA	\$12,000	7	10	\$12,000	\$14.51	\$1.45
Replace pool furnace	1	EA	\$28,900	3	20	\$28,900	\$34.95	\$1.75
Replace sand pool filter system	1	LS	\$7,200	3	10	\$7,200	\$8.71	\$0.87
Average Cost Per Unit Per Year								\$201
